**24 Struck by ---Inspection #1317291 All Star Const**

A **48 year old male** was fatally injured when he was **struck by sign** that fell while in the process of removing roof trusses of a restaurant during the demolition process. The main restaurant area was part of a larger strip mall structure and only interior demolition was taking place within that area. Attached to the east end of the main structure was a one-story addition in which employees were working to completely demolish by hand. At the time of the incident, employees were working to remove structural steel roof trusses from the addition.

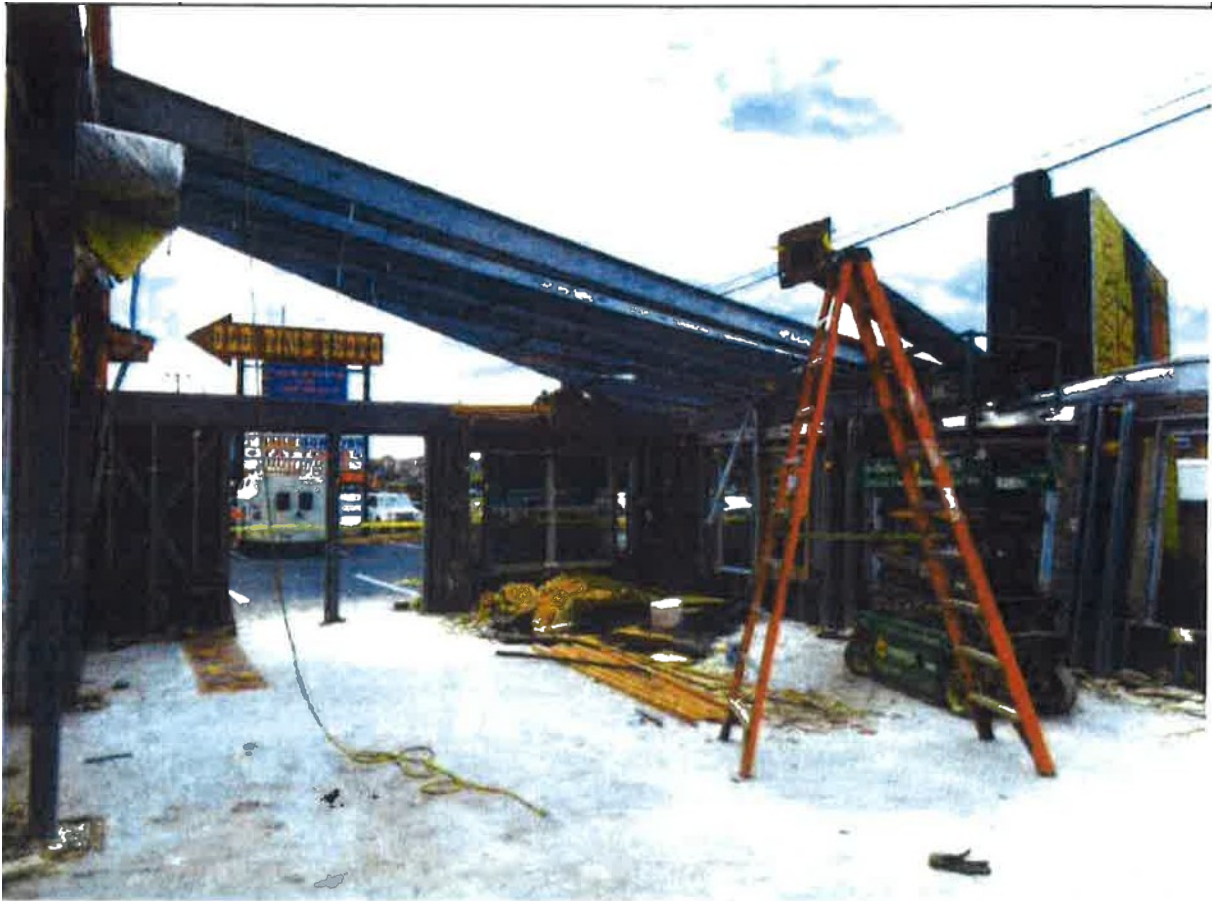
The victim was working with another employee to remove structural roof trusses from the 40' x 29' one-story addition. The roof of the addition was a 2/12 pitch metal roof, in which, the metal had already been removed. The deceased and another employee were working on opposite ends of the addition from step ladders to detach the metal trusses from their mounting points on the east and western side of the addition. It was determined that the employees had successfully removed approximately 20 of the steel roof trusses prior to the incident. Additionally, located in the center of the addition was a large 10' x 15' sign which protruded through the metal roof. It appeared that the sign pole had been positioned between two roof trusses. The sign pole was anchored to the concrete slab with four metal bolts and attached to the roof trusses with two pieces of angle iron bolted to the sign pole approximately 10' from the base of pole.

It is believed that employees working to remove the roof trusses detached the structural attachment system of the sign so that the roof trusses could be removed with the understanding that anchor bolts at the base of the pole would keep the sign pole secured.

Overview of demolition site. Roof trusses employees were working to remove when sign fell.

**29 CFR 1926.850(a):** An engineering survey was not performed by a competent person to determine the conditions of the framing floors and walls and the possibility of unplanned collapse of any portion of the structure prior to permitting employees to start demolition operations.

In that a demolition plan was not developed for Kinkaku Japanese Steakhouse interior and attached addition which resulted in an employee being fatally injured due to the improper removal of a sign that was structurally connected to the roof during demolition operations.

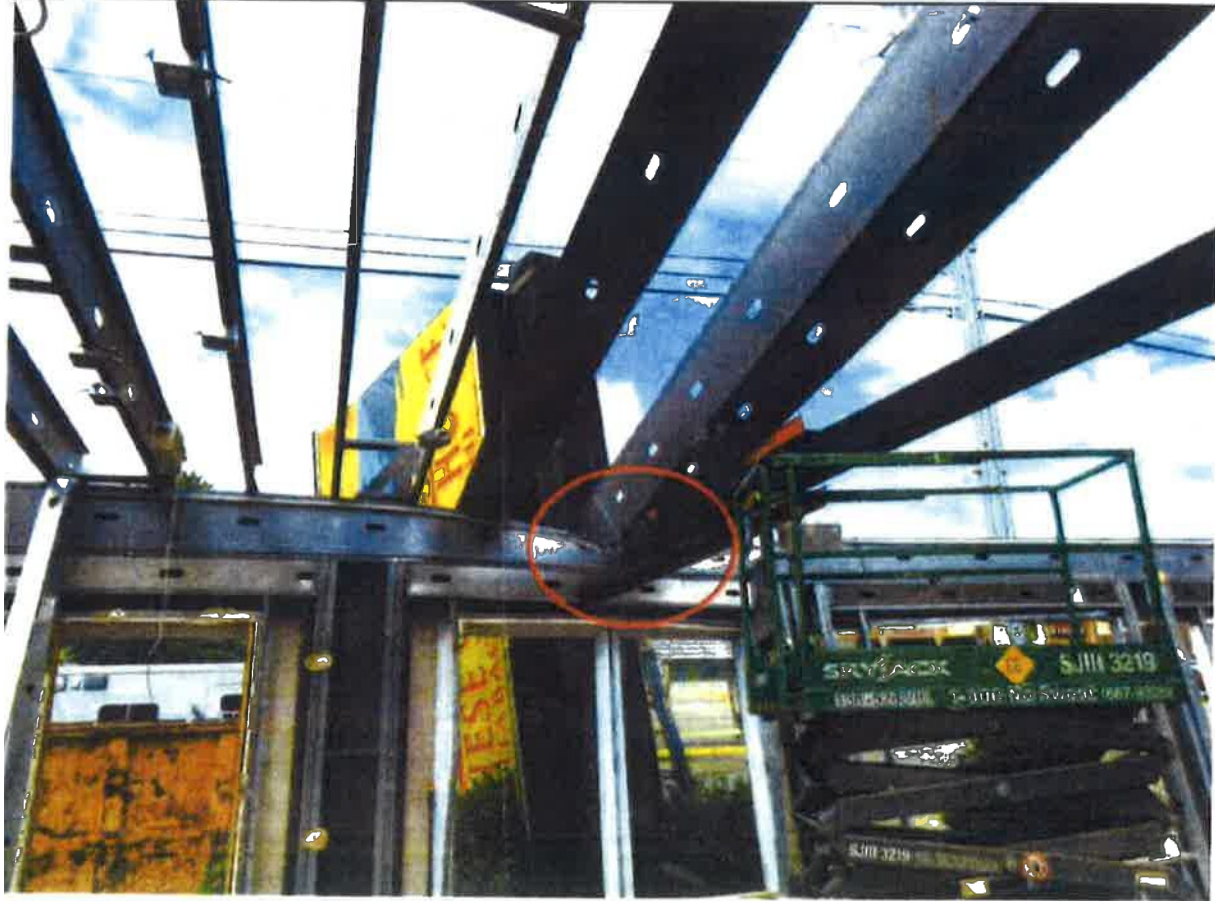
Description:	Area deceased was pinned by sign pole on top plate of eastern wall.
--------------	---
