Crushed by---Insp #1518649 Lodge Manufacturing Company

A **49 year old male** employee was **crushed** when a stand-up forklift he was operating went off the edge of a loading dock and turned over on him. This is a warehouse and distribution site for Lodge Manufacturing Company which manufactures and sells iron cookware primarily. The facility is an approximately 212,000 square foot warehouse facility with 50 foot ceilings that included administrative offices, storage area, and a total of 24 dock doors for loading merchandise onto trucks for distribution.

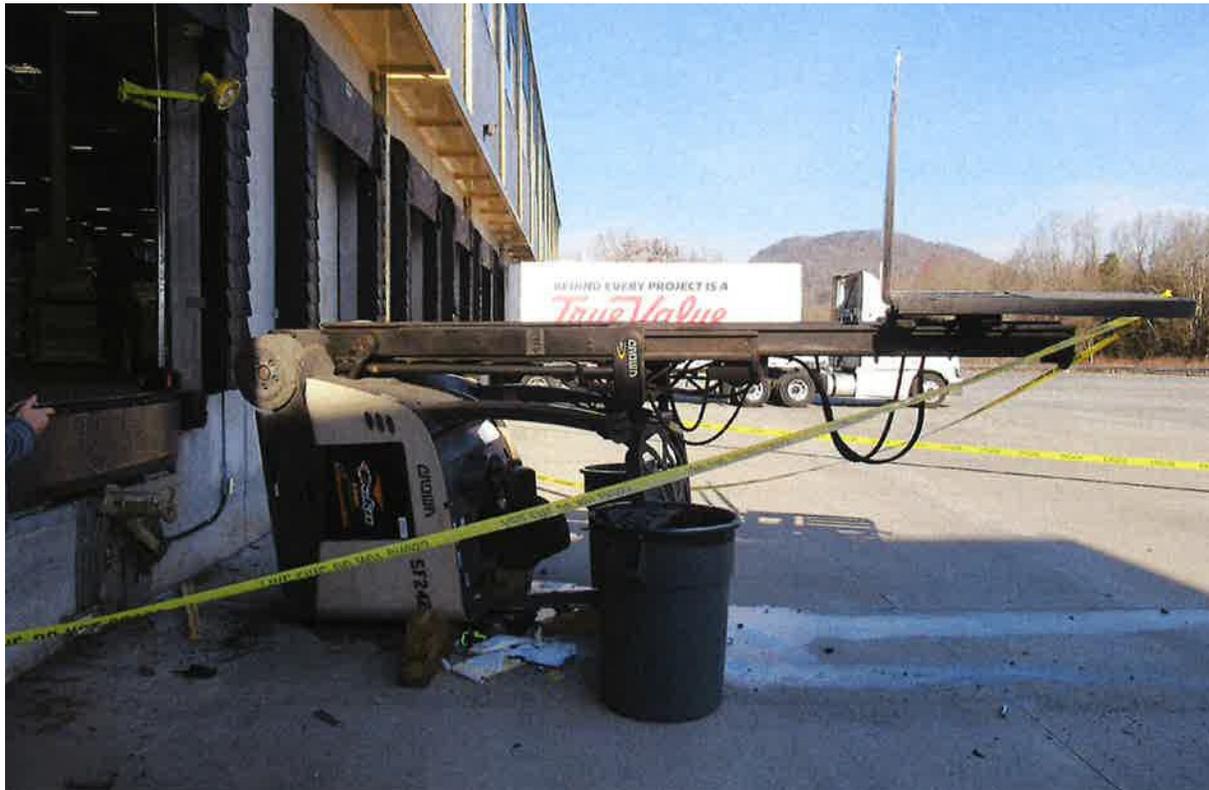
On the day of the incident, the victim was operating the stand-up forklift all day loading trucks and at approximately 6:45pm he had completed loading a truck and was driving his lift to the office on the northeast corner of the dock area to turn in his paperwork. He did not have a load on his forks and was travelling west to east directly adjacent to the dock doors on the north side of his route. Video from the employer's security video shows that the victim travelled from approximately dock door 20 east toward the administrative offices until he approached dock door 4. He was driving the lift with the forks trailing and the operator side leading. The victim was standing at the controls with his back to the north and looking over his left shoulder as he steered the equipment. As he approached dock door 5, his lift appeared to drift to the north a little placing him closer to the openings of the dock bay rollup doors. Directly in front of dock door 4, his lift turned abruptly, and he drove through the open dock door and it immediately fell on its operator position side, crushing him on the ground below resulting in the fatality.

Interviews indicated that prior to the incident, the employees staging the inventory for the loaders would place pallets and boxes of merchandise this close would not allow forklifts room to maneuver the equipment without having to travel close to the dock doors.

According to employee interviews, the staging area between the facility rack system and the dock doors had expanded over the years of operation. It was demonstrated that the floor of the warehouse had faint traces of paint or tape lines that indicated that the inventory was to remain at least 14 feet from the opening of the dock, but the lines had become worn and not replaced. Instead, the inventory had become habitually placed at approximately 11 feet 3 inches from the door openings.

Employee interviews indicated that the overhead rollup doors of each of the 24 dock bays remained open most of the time, regardless of a truck being parked there or not. If it were cold outside, the doors would be closed to preserve heat in the building; but otherwise, they were routinely left open. There was no form of guarding at the door openings to protect the employees from inadvertently falling out the door.

29 CFR 1910.178(m)(6): The employer did not ensure that safe distance was maintained from the edge of ramps or platforms while on any elevated dock, or platform or freight car.

In that employees were exposed to fall hazards due to limited space to operate forklifts directly adjacent to the 24 dock doors on the north wall of the facility as the merchandise that was staged for loading restricted the travel lane to approximately 10 feet and 8 inches.

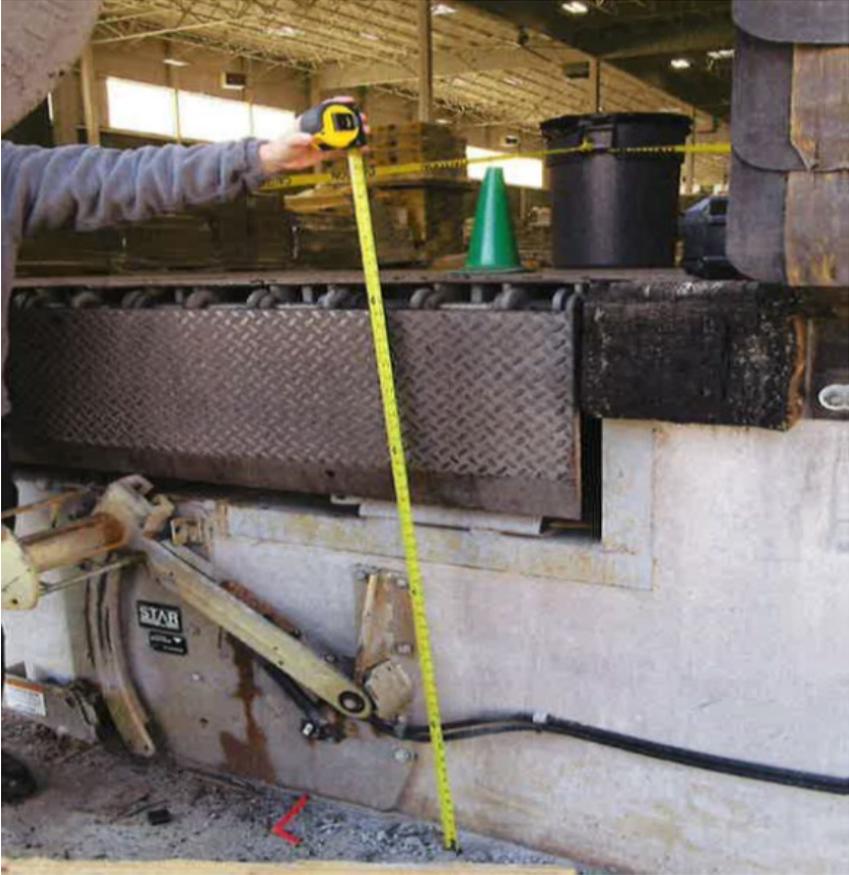
A third-party company recovered the damaged lift and inspected it for defects and damage caused by the incident. The report indicated that the steering and brakes were intact, operational and within specs. Training records indicated that the victim had recently been re-trained and evaluated. The inspection records indicated that the forklift had been inspected pre-shift on the day of the incident.
