A **66 year old female** employee was **struck by a forklift** as she stepped out into the aisle from a blind corner. The victim fell to the concrete floor hitting her head. This incident was reported as a hospitalization, however, the victim succumbed to her injuries about 9 days later.

2--Struck by forklift—Insp #1726215 HDK Industries Inc.

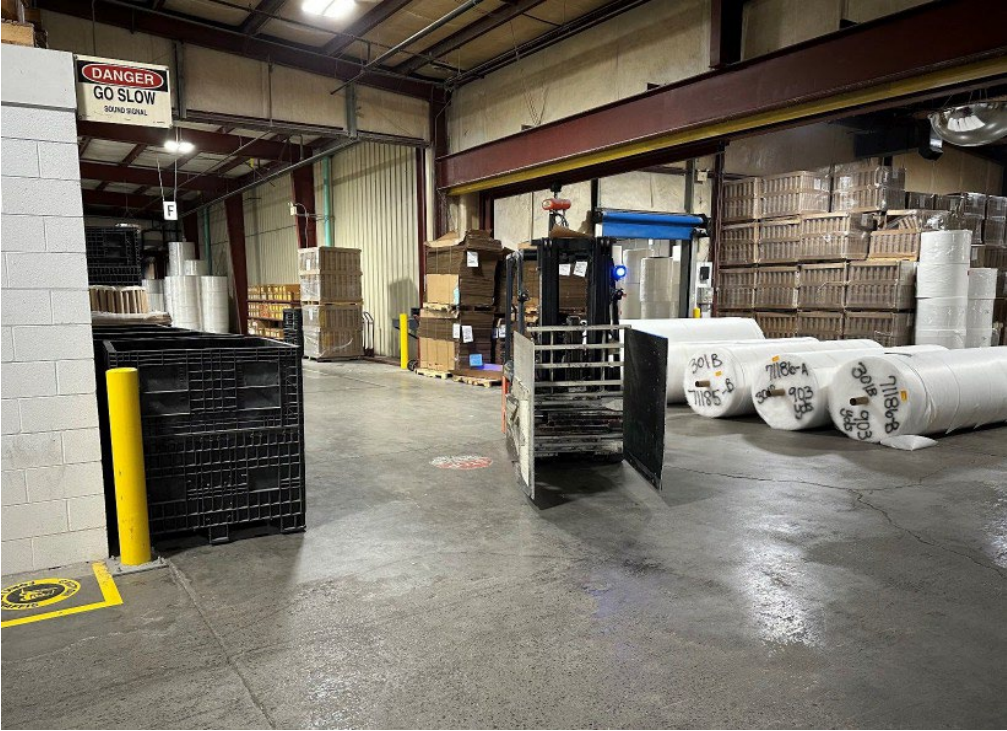
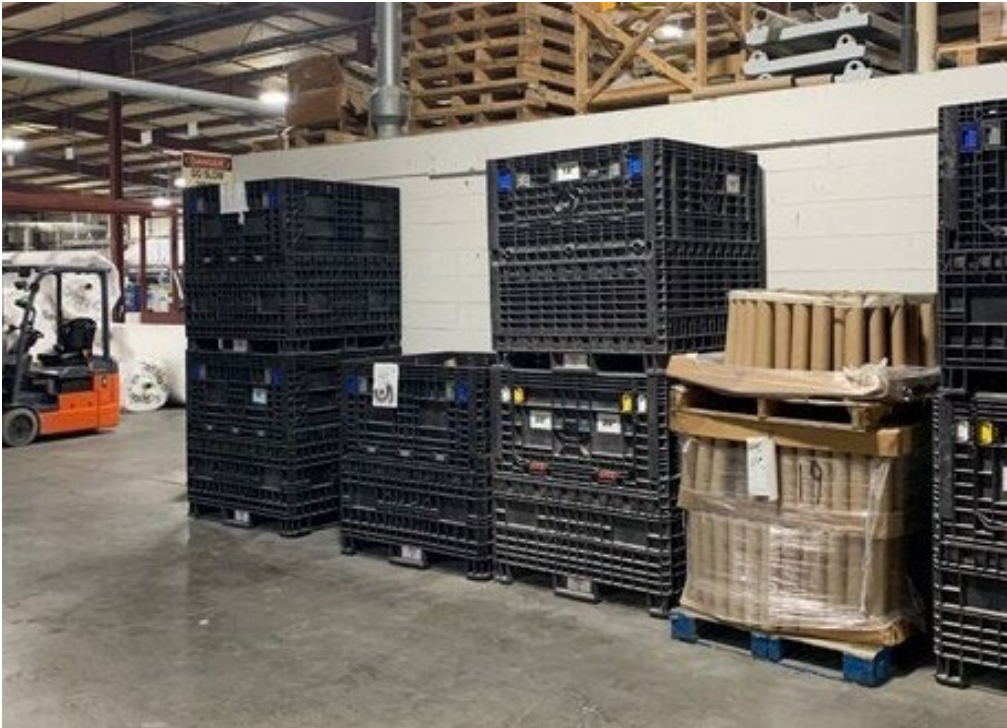
Furthermore, this incident was initially handled as a hospitalization by TOSHA conducting a Rapid Response Investigation (RRI). The employer conducted an internal investigation in which a storage issue with what was referred to as "core totes" was discovered. These large plastic bins are 4 feet tall and 4 feet wide. The company had some of them stacked two-high right at the corner at the time of the incident. Company pictures taken after the incident show this storage configuration and illustrate how it could have played a role in this unfortunate event.

In that four employees were exposed to struck-by hazards due to abrupt interactions between powered industrial trucks (PIT) and pedestrians caused by the storage and stacking of large plastic bins (a.k.a. core totes) at a blind corner in the B building area of the factory.

**29 CFR 1910.176(a):** Where mechanical handling equipment was used, sufficient safe clearances were not allowed for aisles and wherever turns or passage were made. Aisles and passageways were not kept clear and in good repair, with no obstruction across or in aisles that could create a hazard. Permanent aisles and passageways were not appropriately marked.
